# Healthy Lakes, Healthy Communities!

**Kawartha Lake Stewards Association  
2017 Annual Lake Water Quality Report**

**May 2018**

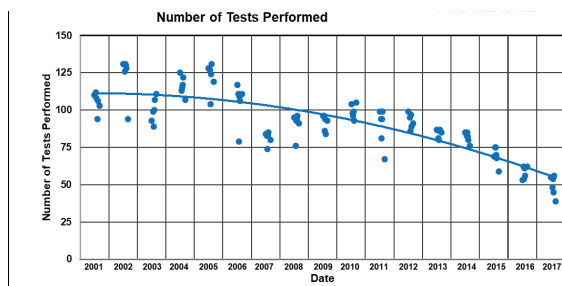
Figure 1. Number of KLSA *E. coli* tests performed each year

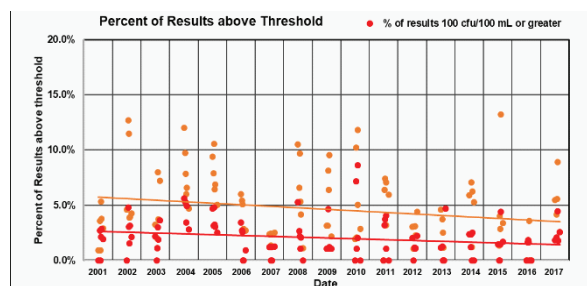
Figure 2. Percent of KLSA *E. coli* test results that exceed KLSA and Provincial threshold:

The actual number of test results that equal or exceed KLSA and Provincial thresholds is very small. In 2017, typically 1 result in 25 (~4%) exceeded the KLSA threshold and 1 test in 70 (~1.5%) exceeded the Provincial threshold. In all results between 2001 and 2017, typically 1 test in 50 (~2%) exceeded the Provincial threshold.

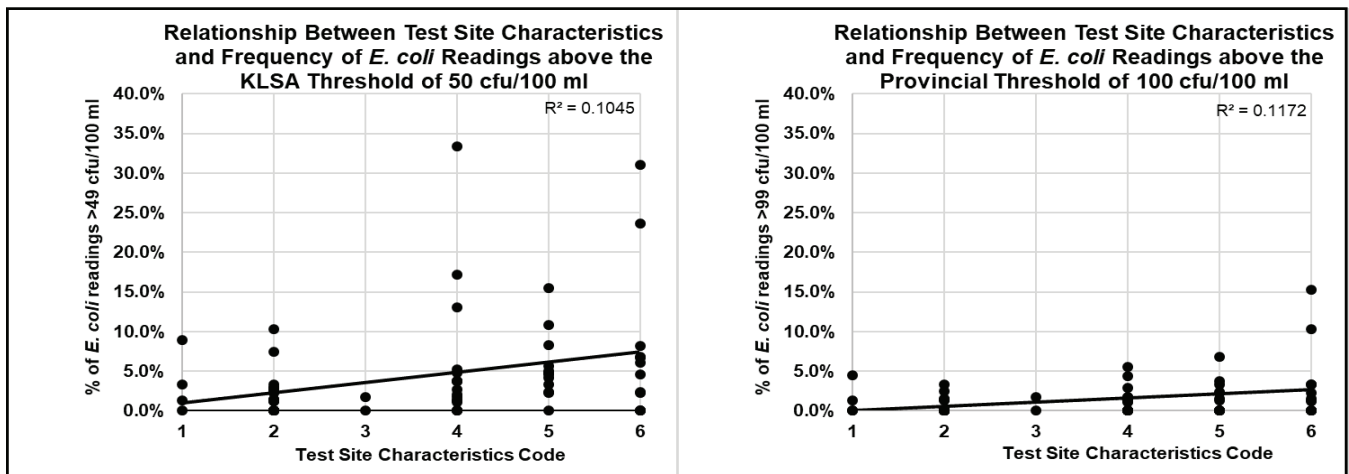
Figure 3. Relationship between test site characteristics and the frequency of *E. coli* results equaling or exceeding KLSA and Provincial thresholds.

would be perfect correlation) indicating that the results cannot be considered to be statistically significant. It is probable that combinations of factors are influencing the results.

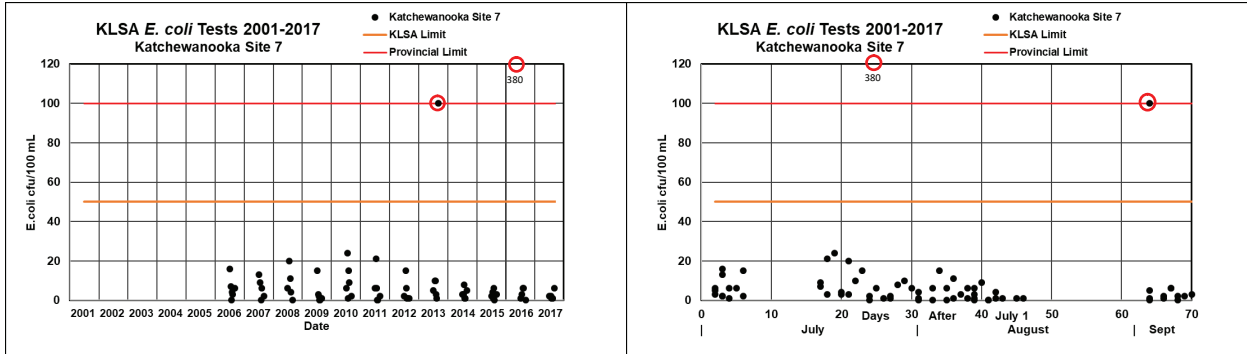
Figure 4. *E. coli* results for Katchewanooka Lake Site 7 over the years (left plot) and seasonally (right plot).

To better evaluate individual sites, the *E. coli* results for sites with at least 10 years of data were graphed over time and seasonally as illustrated in Figure 4 which shows results for the site that I have tested since 2006, Katchewanooka Lake Site 7. This test site is in front of my cottage which is in a bay and adjacent to a wetland and hence I characterize it as a category 4 site. Geese do nest in the local area and every year during spring and early summer there are usually flocks of 30 or more (four or more adults plus their goslings) that cruise around looking for lawns to feed (and defecate) on.

The results in Figure 4 show that between 2006 and 2012 before these measures were implemented, *E. coli* levels typically reached ~20 cfu/100mL whereas in later years *E. coli* levels typically reached only half this amount. As expected, the seasonal plot indicates that the higher readings were in the early summer when goslings cannot fly and adult geese are molting (renewing flight feathers). By mid-August they are all able to fly and usually move on to areas of better foraging. While it cannot be proven that the measures taken to deter geese are responsible for the reduction in *E. coli* levels in recent years it appears to be the most probable explanation.

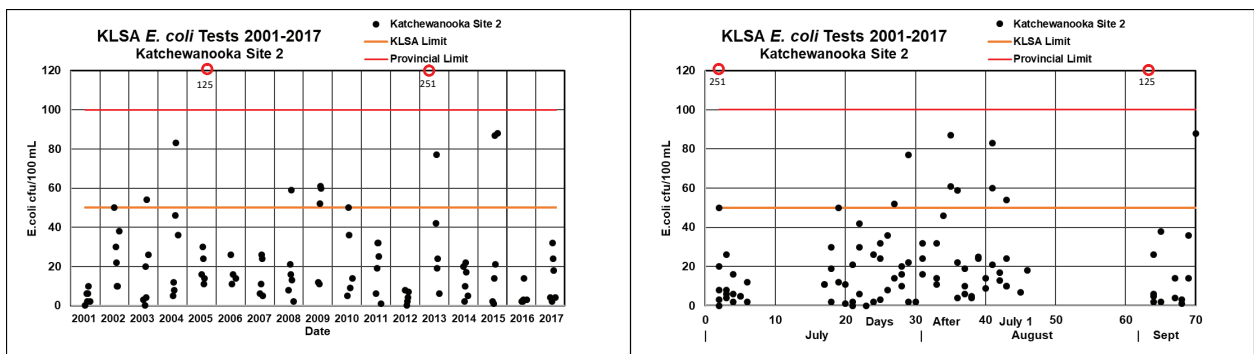
Figure 6. *E. coli* results for Katchewanooka Lake Site 2 over the years (left plot) and seasonally (right plot).

Katchewanooka Lake Site 2 has been tested continuously between 2001 and 2017 with *E. coli* results shown graphically in Figure 6. The site is located about 80m downstream from a rocky offshore shoal where gulls congregate throughout the summer and fall, Figure 7. *E. coli* readings have been variable between 0 and 100 cfu/100mL over the 17 years of testing with high readings occurring variably at all times of year. Again, it cannot be proven that gulls are responsible for the sustained elevated *E. coli* levels over the years but it appears to be the most probable explanation. It would probably be neither easy nor appropriate to attempt to interfere with this natural situation.

During the seventeen years of testing at this site only two unusually high readings occurred as indicated in Figure 6 by red circles - one of 125 cfu/100mL that occurred in September, 2005 and the other 251 cfu/100mL that occurred in July, 2013. These results are considered to be outliers.

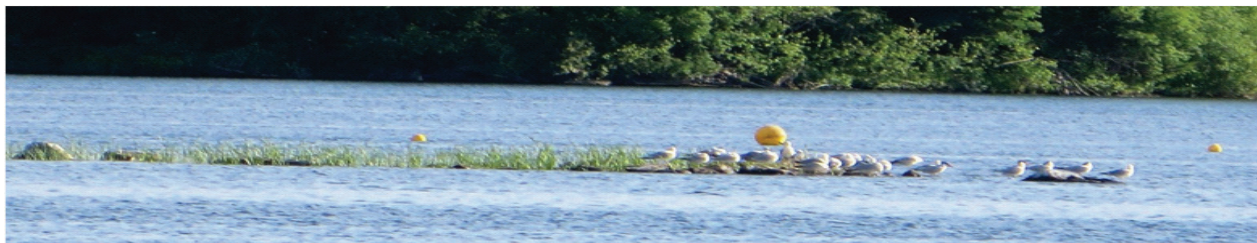
Figure 7. Gulls roosting on a rocky shoal upstream of Katchewanooka Lake Site 2

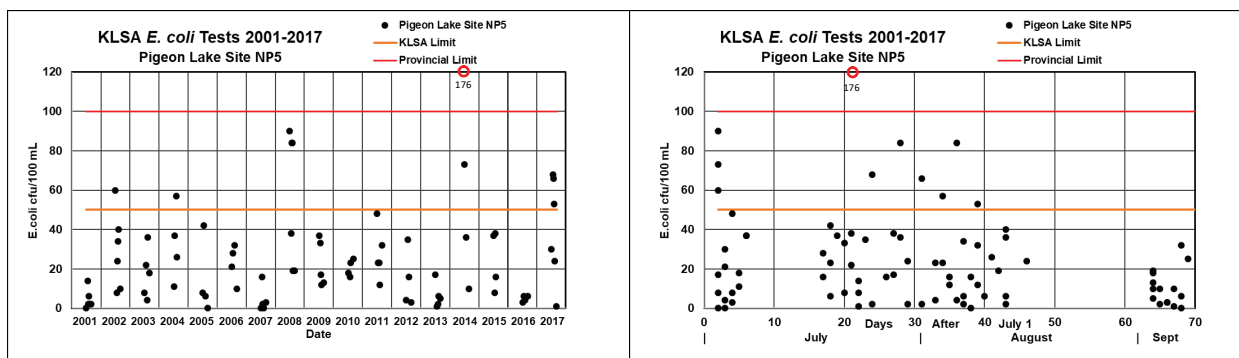
Figure 8. *E. coli* results for Pigeon Lake Site NP5 over the years (left plot) and seasonally (right plot).

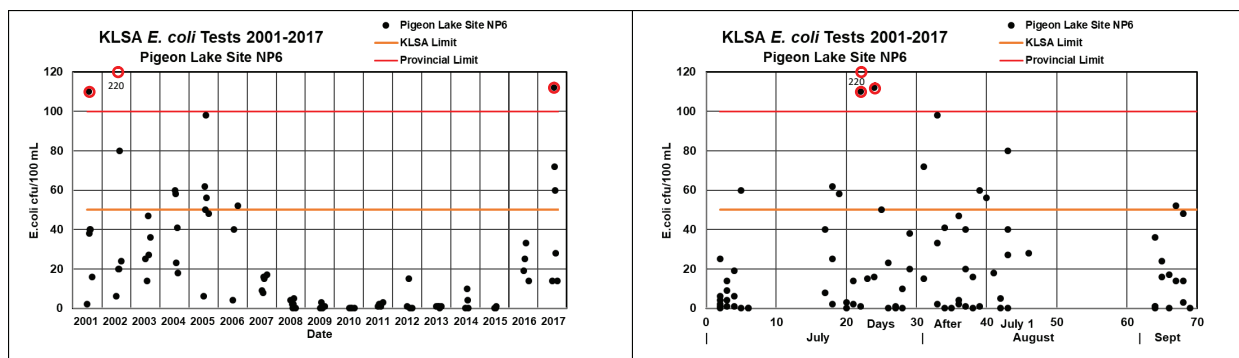
Figure 9. *E. coli* results for Pigeon Lake Site NP6 over the years (left plot) and seasonally (right plot)

It was discovered that in 2015 the owner of the property adjacent to Site NP6 was charged by the Ontario Provincial Police with killing goslings contrary to provisions of the Migratory Birds Convention Act. It was stated that "The man was angry that the geese were defecating on the grass and a beach area". It is surmised that the owner began deterring geese from entering his property about 2007 and continued until charged in 2015. Meanwhile, it appears that the geese were still active in the area as shown by the continued variably high results during this period at Site NP5 nearby. Once again it should be stated that without further investigation it cannot be proven that the significant reduction in *E. coli* at Site NP6 between 2007 and 2015 was due to the alleged illegal action, but it appears to be the most probable explanation.

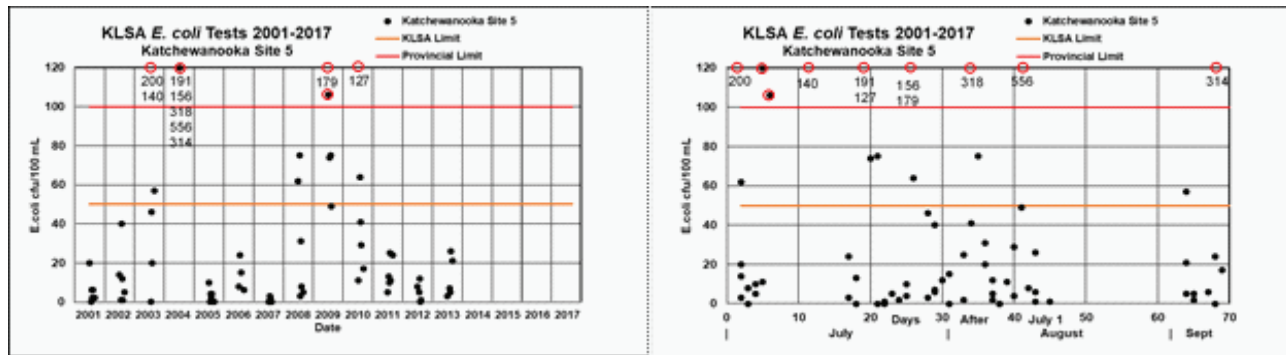
Figure 10. *E. coli* results for Katchewanooka Lake Site 5 over the years (left plot) and seasonally (right plot).

Outliers, or *E. coli* results greater than 100 cfu/100mL, occur infrequently for most sites; typically, about one for every 50 tests performed. When retests are requested and performed a few days later, the result is almost always a return to low values. This is not surprising. Healthy humans excrete about 100 million *E. coli* bacteria per ¼ teaspoon of fecal matter, (Mackenzie, K., KLSA 2005 ALWQR, page 56). Other mammals and birds that share our lakes also produce large amounts of *E. coli* and thus it is not surprising that high test results will occasionally occur. Only if they are frequent or repeatable should they be a cause for concern and investigation. An example of this occurred in 2004 at Katchewanooka Lake Site 5 as shown in Figure 10. This site is at the mouth of a creek that crosses many farms before emptying into Katchewanooka Lake. In early 2003 and throughout 2004 *E. coli* results were sustained above the Provincial threshold. It was concluded that a farmer was pasturing his cattle adjacent to the creek allowing their feces to contaminate the water.

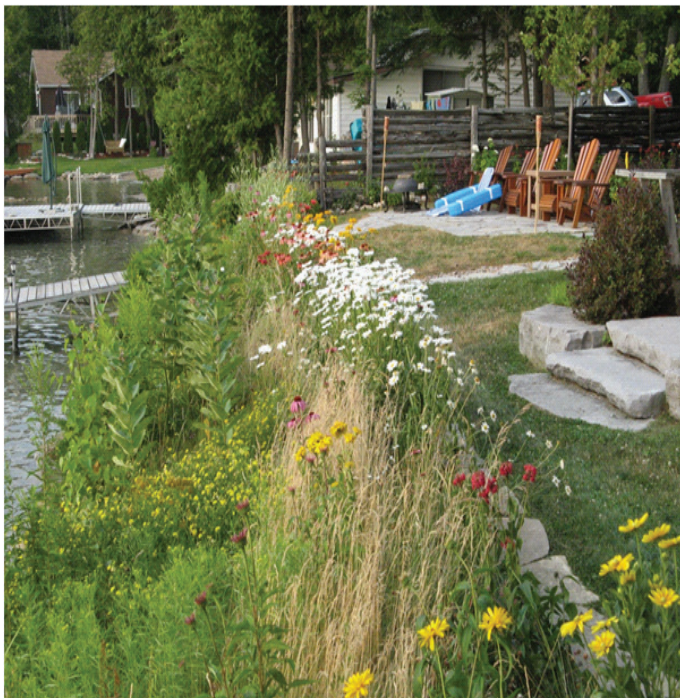
Fig. 1: When planted along the shore, the strong, deep root systems of native plants help to anchor the soil, reducing the amount of material carried away by rain, waves, wind and snowmelt.

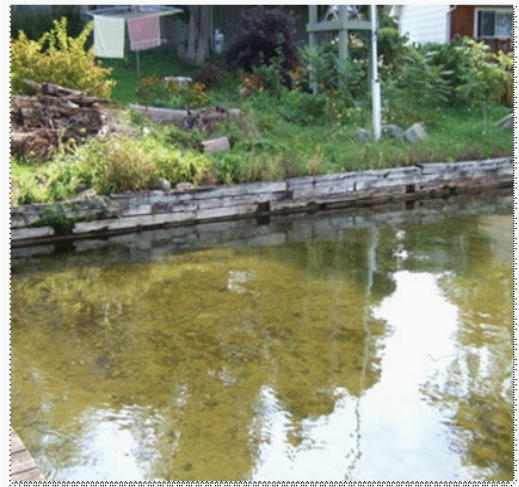
Fig. 2 (Before): Wooden structure holds the soil in place. *Photo by Kawartha Conservation*

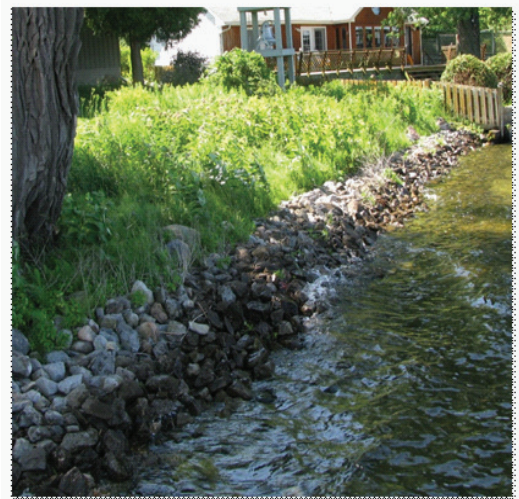
Fig. 3 (After): Sloped rock and natural vegetation provide a healthy and stable shoreline.

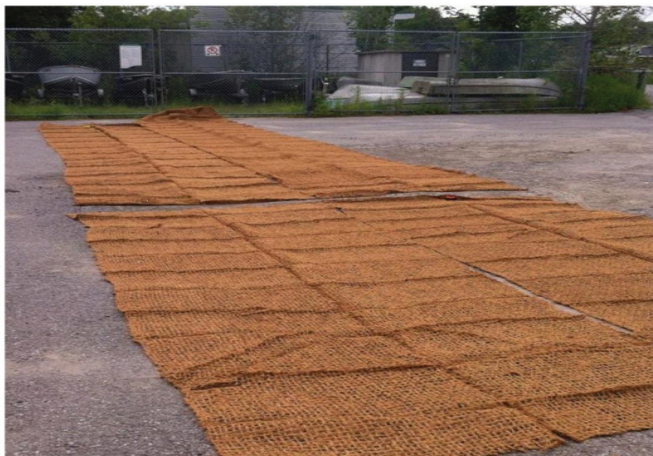
Biodegradable Mats

Biodegradable mats measuring four metres by ten metres were prepared using coir material made from coconut husk. Between mid-to-late July, six mats were submerged overnight at all treatment sites, where they were reinforced with heavy rocks to allow full saturation and prevent buoyant uplifting. Following this, four different species of native aquatic plants were planted into each of the mats. Native submersed plants that were used included: Robbins pondweed (*Potamogeton robbinsii*), broad-leaved pondweed (*Potamogeton amplifolius*), coontail (*Ceratophyllum demersum*) and tapegrass (*Vallisneria americana*).

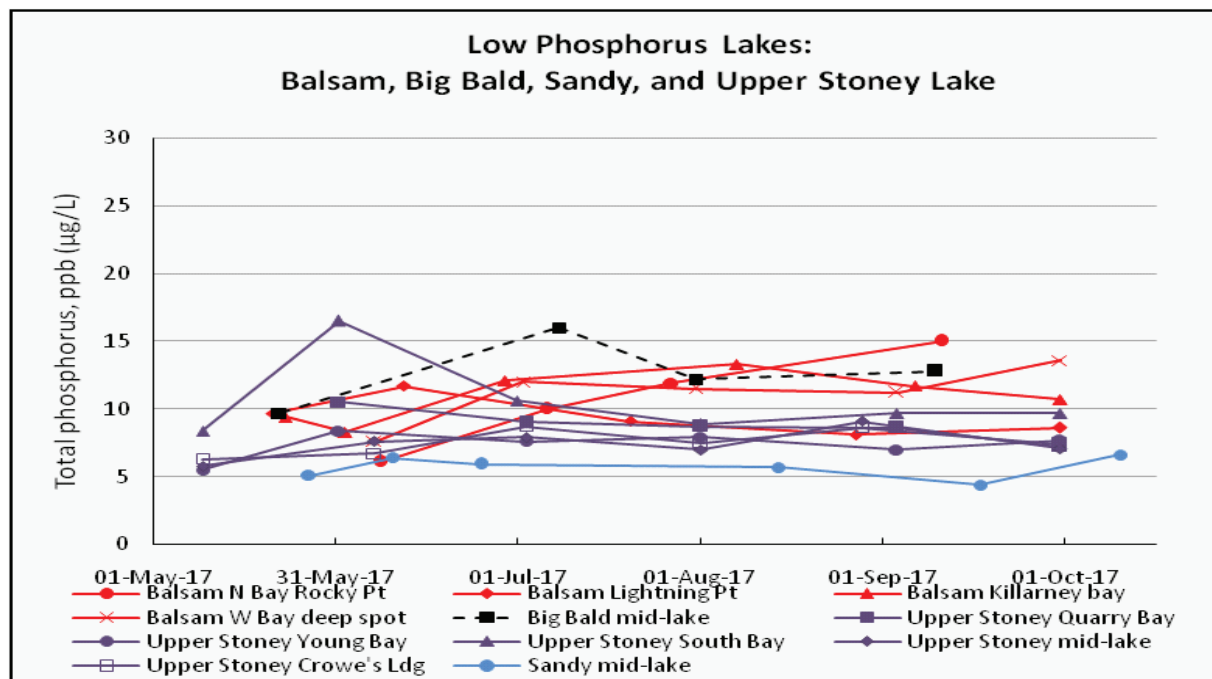
The phosphorus levels in these lakes remained under 15 ppb all summer. Upper Stoney and Balsam Lake are fed with low phosphorus water from the north all summer. Sandy Lake is chemically unique among the Kawarthas, as much of its phosphorus is precipitated down into the sediments to form marl.

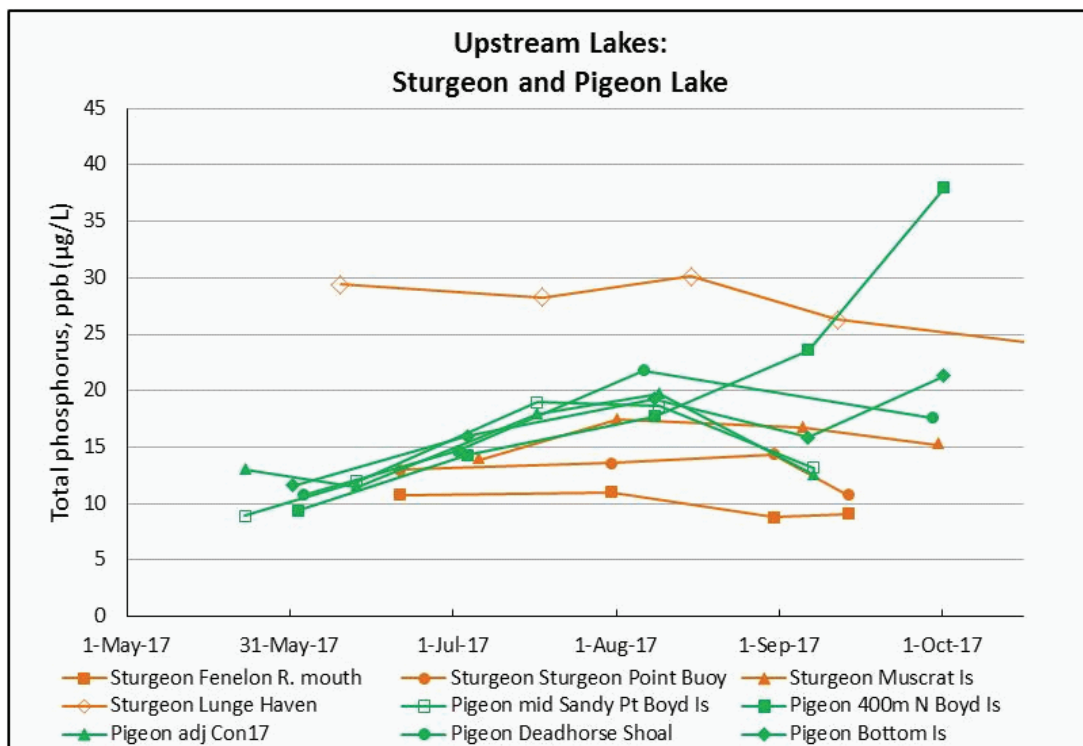
As water flows down the Trent-Severn Waterway (TSW), the phosphorus levels rise somewhat. The Lunge Haven site is an exception; it is at the south end of Sturgeon Lake where it receives inflows from Lindsay via the Scugog River. It is the mixing of this high phosphorus water with the water from the Fenelon Falls site that results in higher phosphorus level at Sturgeon Point. The high reading in October at Pigeon Bottom Is. is puzzling; there was a rise similar to this in 2016.

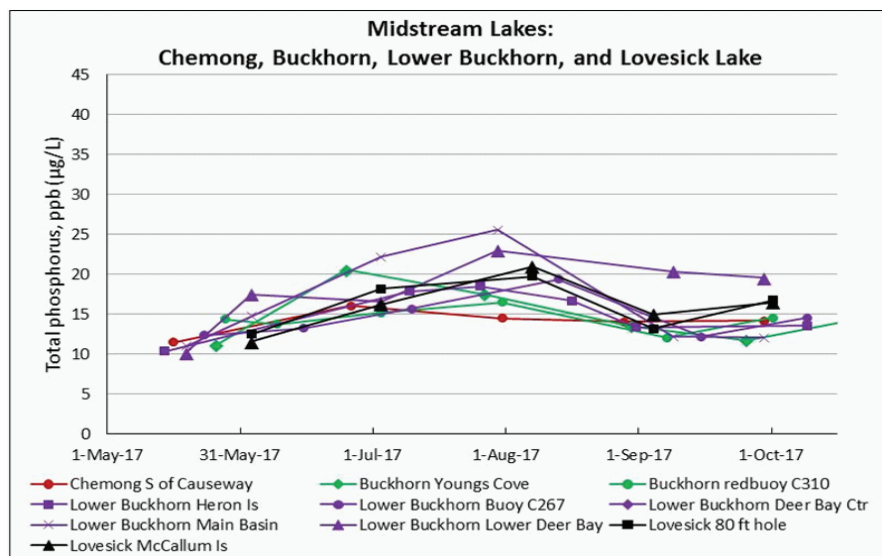
These lakes have similar phosphorus levels to the upstream lakes. As in previous years, there are somewhat higher levels in the Lower Deer Bay and Lower Buckhorn Main Basin sites.

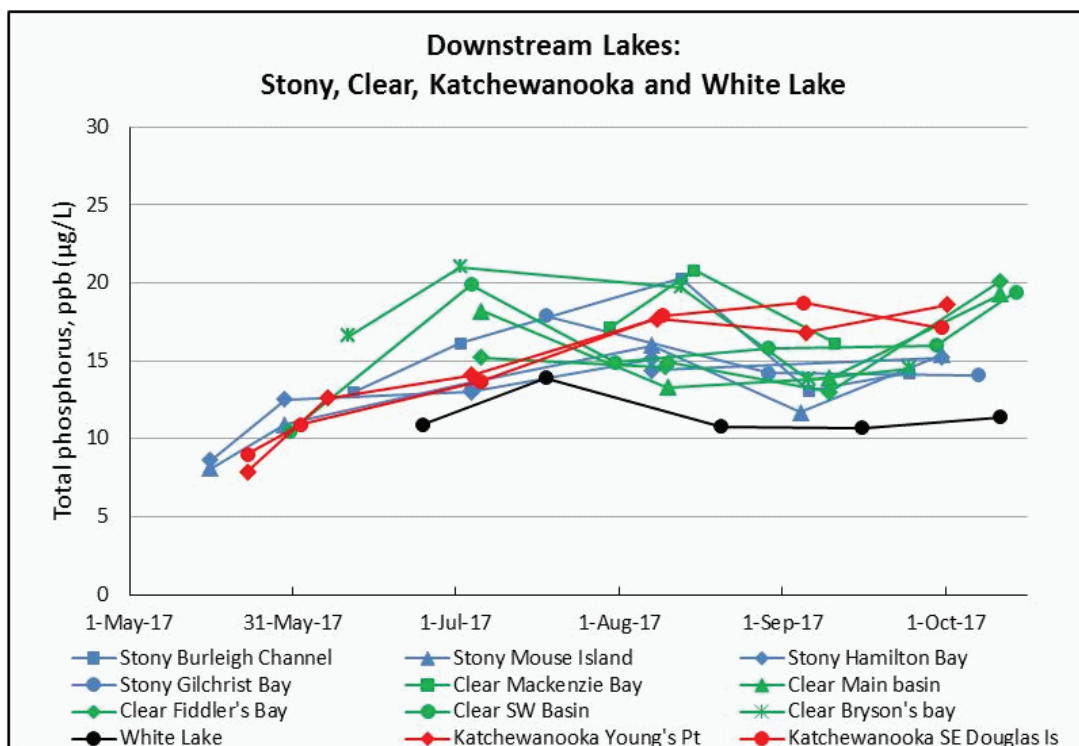
As seen in previous years, Stony Lake's phosphorus levels at the Burleigh Channel are similar to Lovesick Lake, which is directly upstream. However, the other two Stony Lake sites, which are mixed with water from low phosphorus Upper Stony Lake, are somewhat lower in phosphorus. Levels increase slightly in Clear Lake and are similar in Katchewanooka. As usual, White Lake, which flows directly out of Gilchrist Bay on Stony Lake, has relatively low phosphorus levels. Our guess is that there are low phosphorus springs that feed this small, relatively shallow lake.

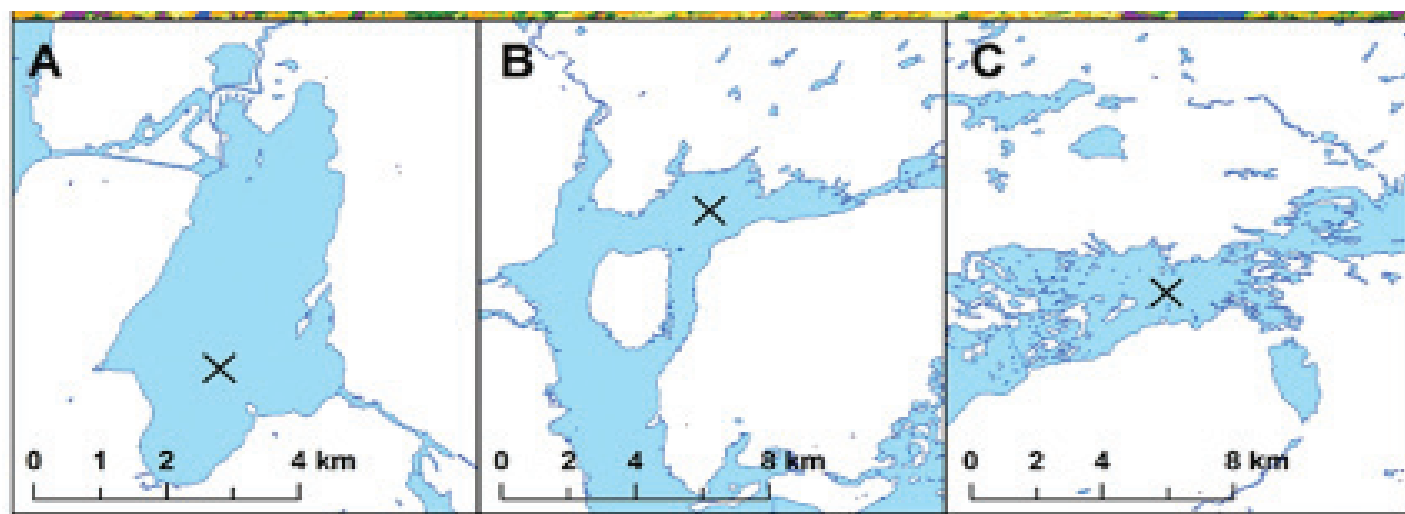
Map showing the location of the cores in the three Kawartha study lakes used in this study:  
( A: Cameron, B: Pigeon, C: Stony)

The Kawartha Lake Stewards Association (KLSA) along with its partners have undertaken a sediment core study at the bottom of three lakes (Cameron, Pigeon and Stony) to identify whether or not these lakes were subject to human-induced eutrophication (also called cultural eutrophication). Eutrophic status refers to the productivity of a lake, with oligotrophic being low nutrients, low productivity, eutrophic being high nutrients, high productivity, and mesotrophic being somewhere in the middle. Figure 1, "The process of lake eutrophication" (reference: Quebec Volunteer Lake Monitoring Program; Ministère du Développement durable, de l'Environnement et de la Lutte contre les changements climatiques. <http://www.mddefp.gouv.qc.ca/eau/rsvl/methodes-en.htm>), below, shows the various lake stages related to natural, long-term eutrophication over thousands of years under stable climatic conditions, and cultural eutrophication, a process that occurs over decades. Cultural eutrophication results in increased algal biomass (i.e., more primary production caused by nutrient loading). For more information on the origins of this study and the applications of paleolimnology techniques, please see the KLSA 2016 Annual Lake Water Quality Report (Napier and Cumming, Paleolimnology: what is it and why is it useful?; and Cumming and Napier, Kawartha Lakes Paleolimnology Study: Collection, Analysis and Age-dating of Sediment Cores). Sediment cores were collected by Queen's University in three lakes: Cameron Lake, Pigeon Lake and Stony Lake (Cumming and Napier: 2016 KLSA Annual Report).
